Schneider Home Inspections LLC

Property Inspection Report

Client(s): **Jack and Jill Lastname**
Property address: **1111 Your St**
Anywhere WA 99999
Inspection date: **Wednesday, February 26, 2014**

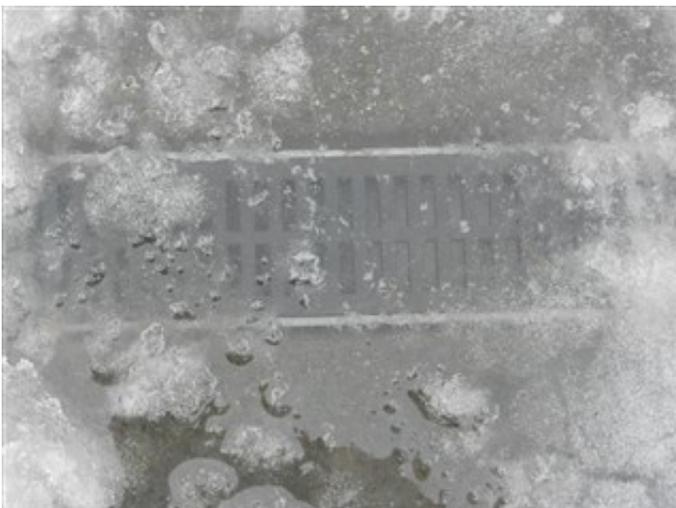
1) Standing water at driveway. Existing trench drain viewed with standing water. Probably clogged with snow and ice. Assume will drain when snow and ice melt.

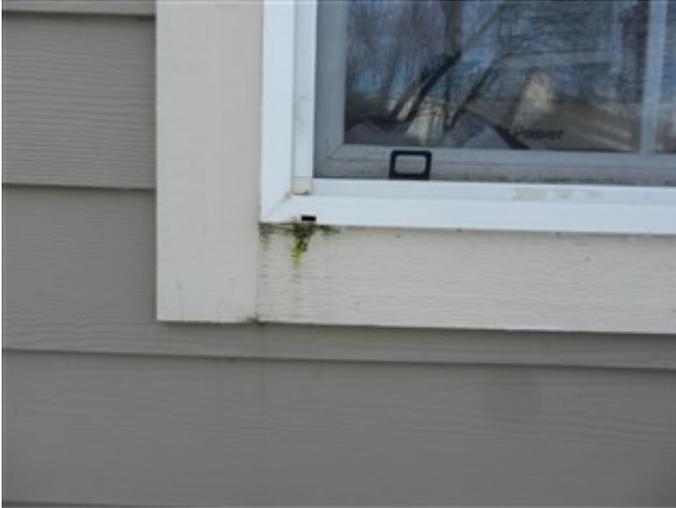
Photo 2-1

2) Some sections of siding and/or trim have minor cracks. Mainly cosmetic, but moisture can enter thru cracks. Recommend that a qualified person repair, caulk and paint siding or trim as necessary.

Photo shows water from roof and rain gutter is causing excessive moisture. Additional photo's with roof drainage problem in roof section.

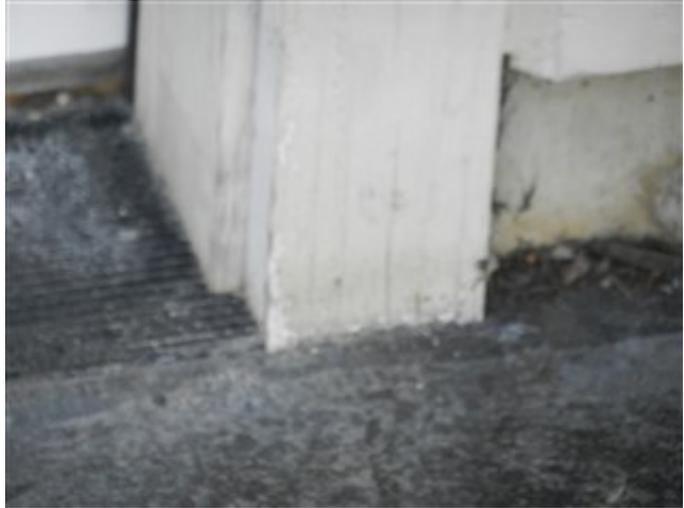
Photo 2-2

contact of trim to concrete outside back garage entrance. Cutting this trim up off concrete will help to prevent moisture from wicking up trim, causing rot and paint failure.

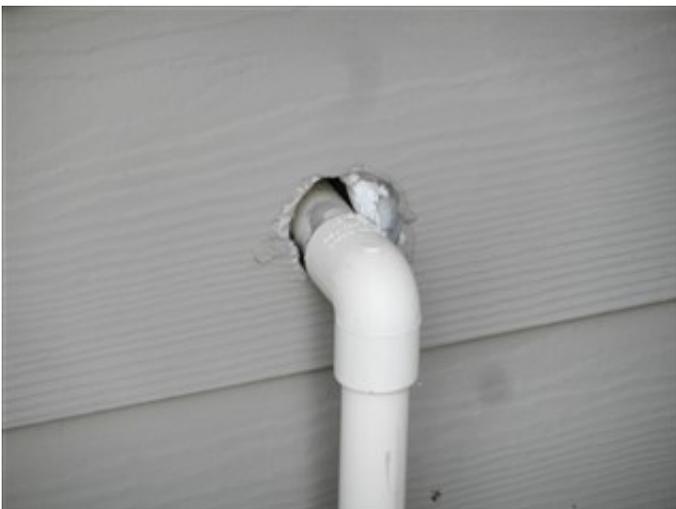
Photo 2-3

Caulk and paint to stop entry of insects and moisture.

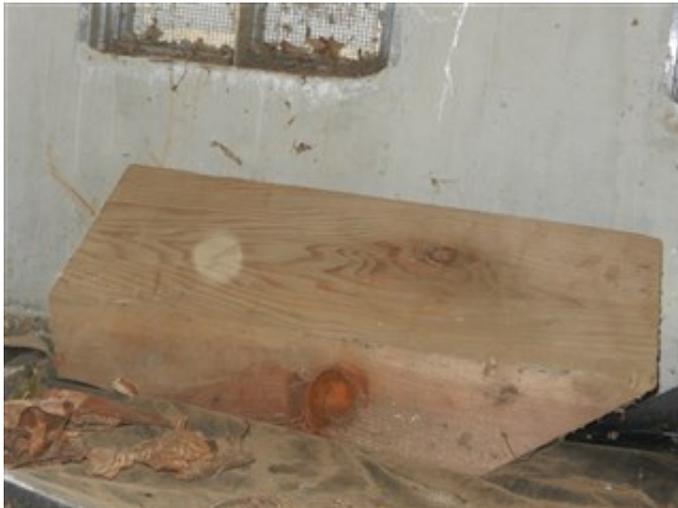
Photo 3-1

3) scrap wood was found next to the crawl space access. Recommend removing all cellulose-based debris or stored items.

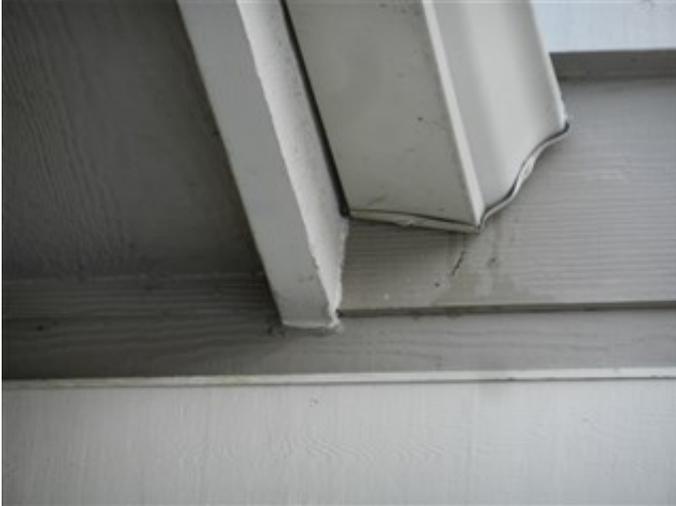
Photo 5-1

Roof kick out flashings on east and west roofs were missing. See photos below for locations and also a photo of proper flashing install at covered patio for reference. Leaks can occur as a result. On the west roof the water has been running around gutter, down siding and behind lower belly band trim. East roof has some visual deteriorated siding and will continue if not addressed. Recommend that a qualified licensed roofing contractor install as necessary. This may appear to be a minor flaw, but left in this condition this may lead to a much more costly repair in the future.

West roof water running around gutter, down siding and behind base belly band

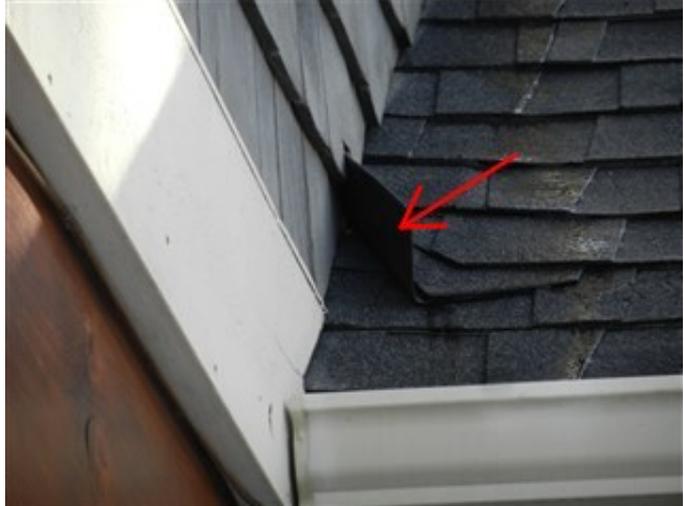
Photo 5-2

Proper flashing at back patio cover for reference

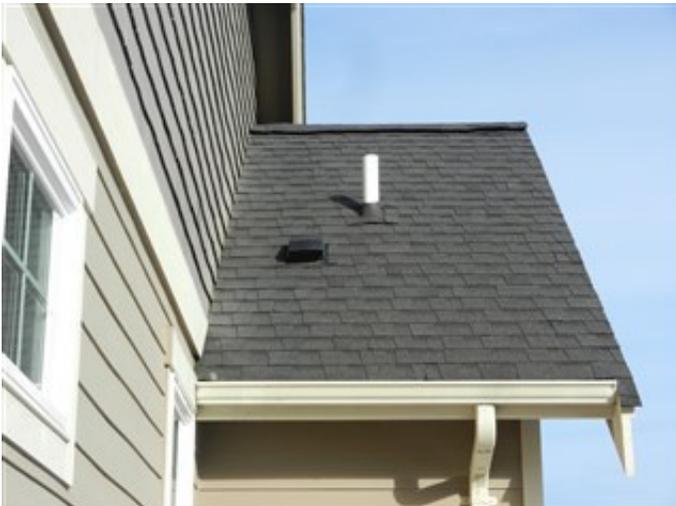
Photo 5-3

East view of roof that requires flashing

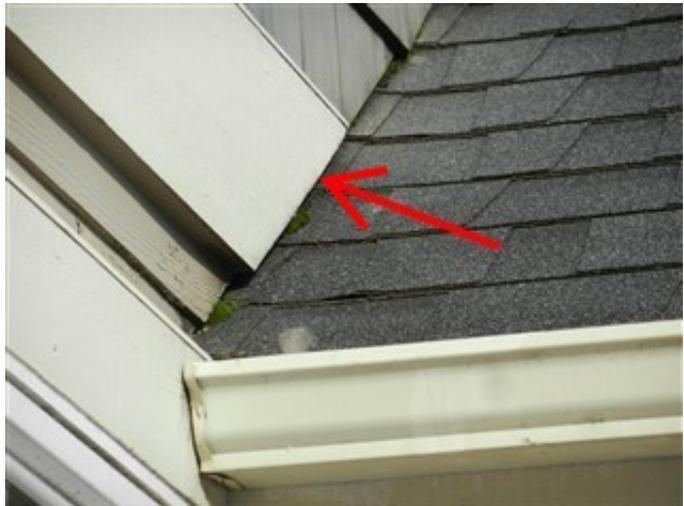
Photo 5-4

East view at location of required kick out flashing.

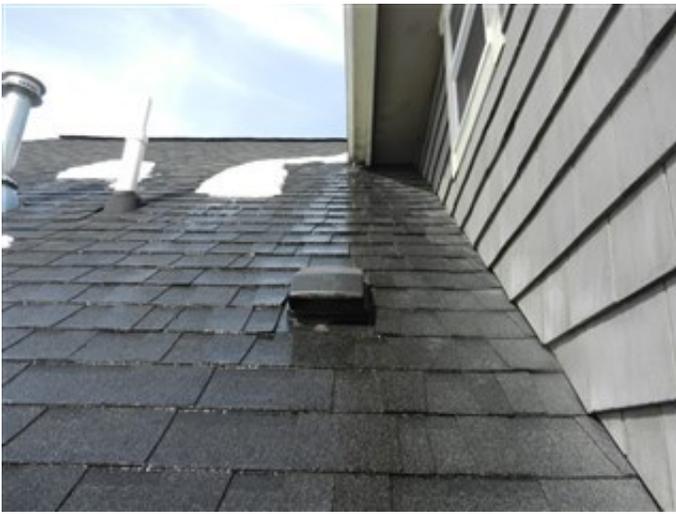
Photo 5-5

West roof view. Existing roof jack is forcing water from gutter above toward siding and problem area.

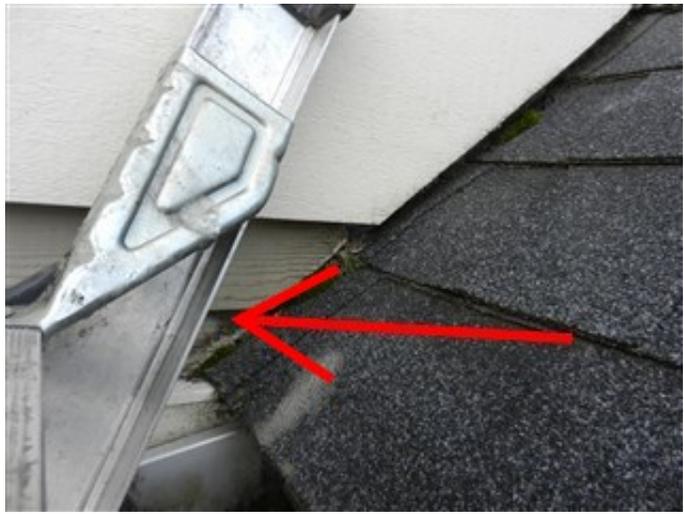
Photo 5-6

East view of deteriorated siding due to water not being diverted by kick out

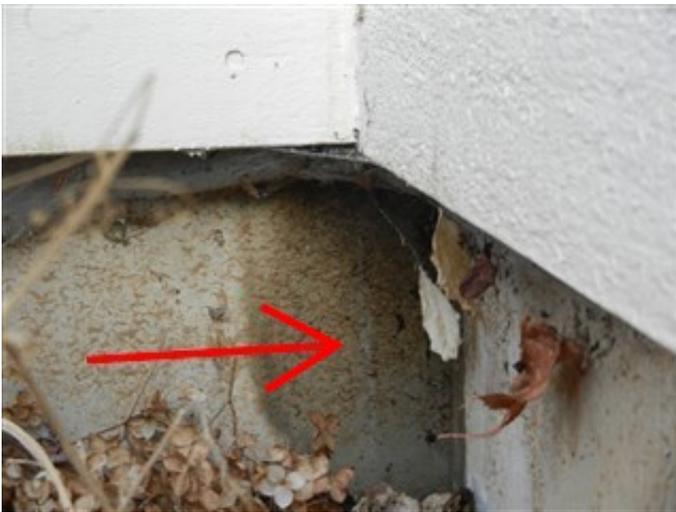
Photo 5-7

The moisture in photo is from the west roof above. It is migrating behind the siding and exiting under the base band trim shown.

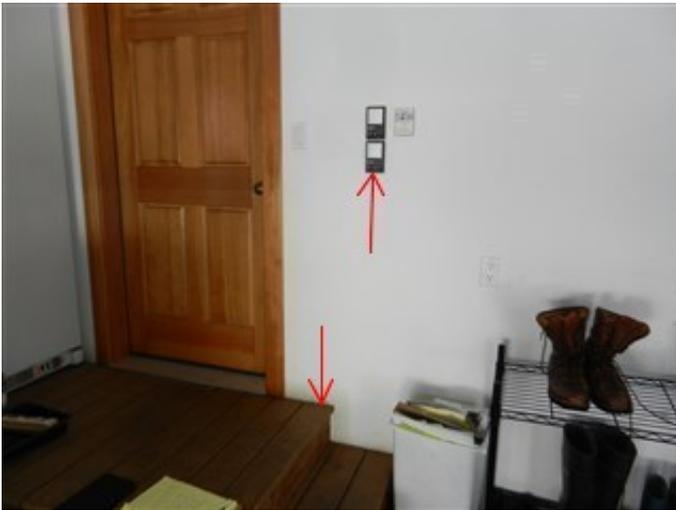
Photo 6-1

The wall-mounted control for both automatic garage vehicle door openers are less than 5 feet off the floor, or within reach of children. This is a safety hazard. Children should not be able to operate automatic garage vehicle door openers. A qualified person should relocate controls for door openers so they are at least 5 feet above floors and/or out of reach of children. For more information on garage door safety issues, visit:

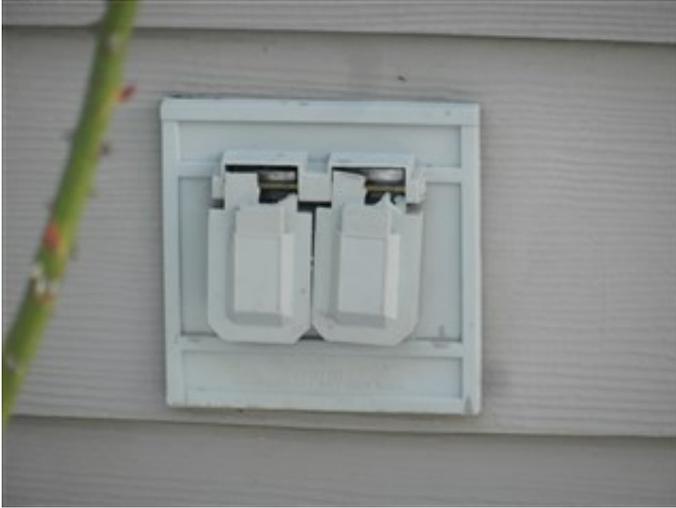
Photo 7-1

Receptacles on exterior have covers broken. Could lead to moisture and children tampering with. This is a safety concern. Recommend that proper covers be installed by qualified person.

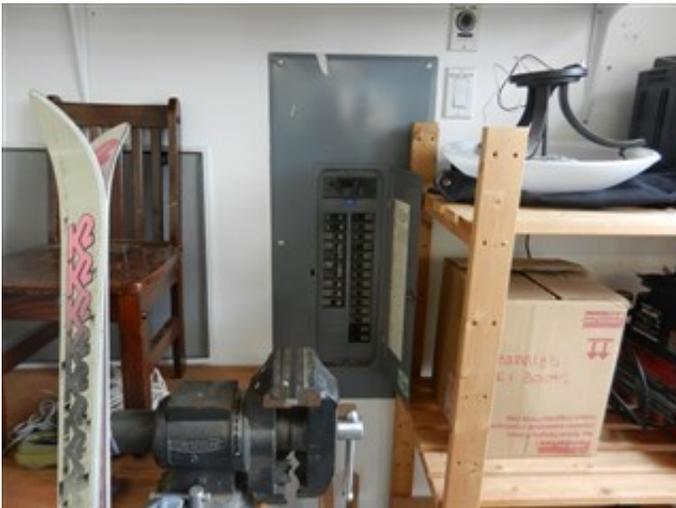
Photo 8-1

The inspector was unable to open and evaluate panel because items were blocking access and built in bench and storage shelving would not allow for removal of the panel cover. This panel is excluded from this inspection. Recommend that repairs, modifications and/or cleanup should be made as necessary so panels can be opened and fully evaluated.

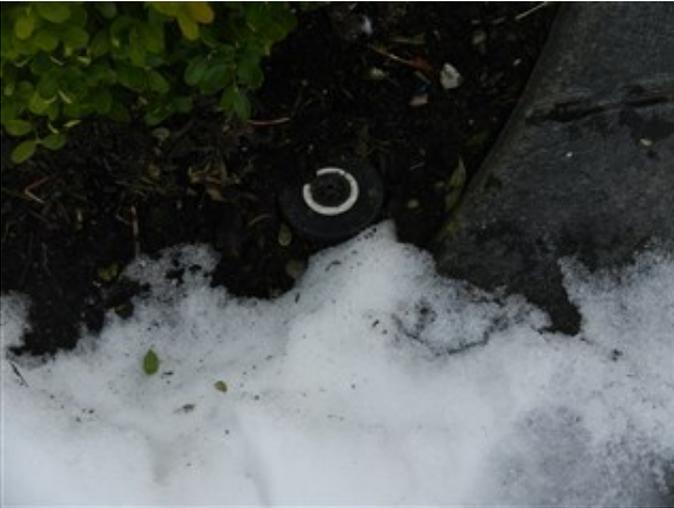
Photo 10-1

10) Based on visible equipment or information provided to the inspector, this property appeared to have a yard irrigation (sprinkler) system. These are specialty systems and are excluded from this inspection. Comments in this report related to this system are made as a courtesy only and are not meant to be a substitute for a full evaluation by a qualified specialist. When this system is operated, recommend verifying that water is not directed at building exteriors, or directed so water accumulates around building foundations. Sprinkler heads may need to be adjusted, replaced or disabled. Consider having a qualified plumber verify that a backflow prevention device is installed per standard building practices to prevent cross-contamination of potable water. Recommend that a qualified specialist evaluate the irrigation system for other defects (e.g. leaks, damaged or malfunctioning sprinkler heads) and repair if necessary.

Visible sprinkler head in flowerbed.

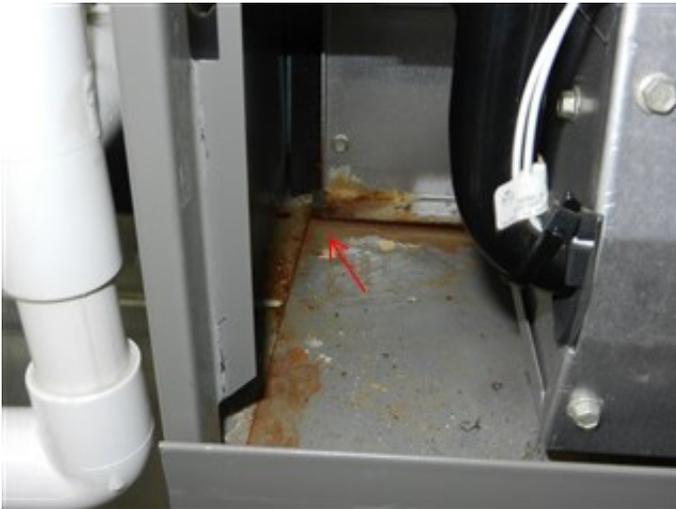
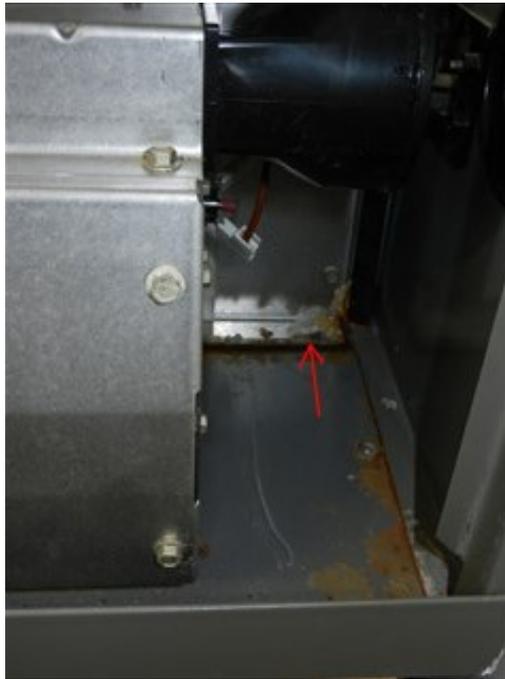
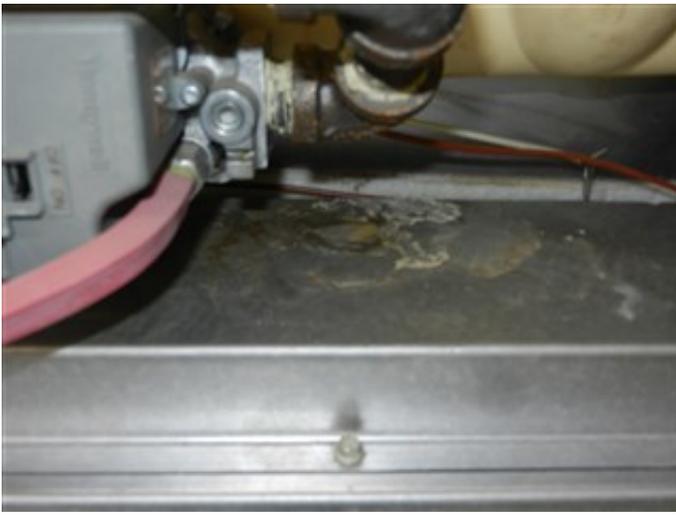
The forced air heating system shows evidence of past excess moisture. It appears from the service record that a service has not been done for over 1 year. Recommend that a qualified HVAC contractor evaluate and make repair as necessary during service.

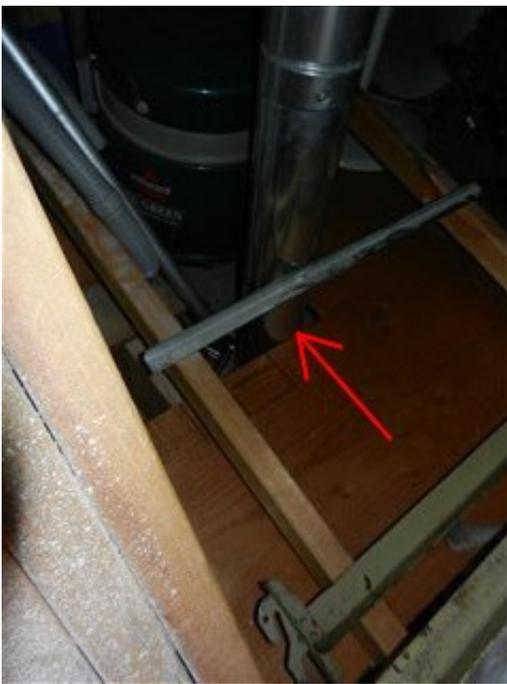
Photo 13-1

B-vent metal flue pipe in attic over garage is contact with combustible materials. This type of vent requires a minimum of 1 inch clearance to such materials. This is a fire hazard. Recommend that a qualified person repair as necessary. For example, by cutting the plywood back for proper clearance.

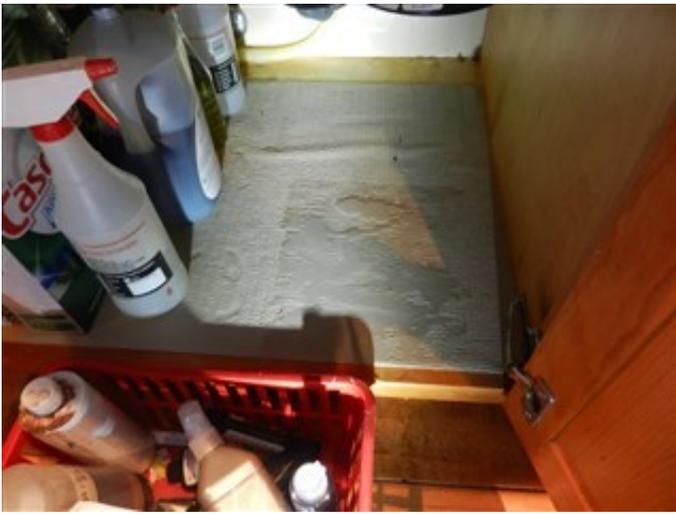
Photo 14-1

The garbage disposal is currently leaking. This may lead to damage of cabinet and may also be a safety risk as it appears that the water is running through the disposal's electrical housing. Possibly coming in contact with electrical components. Recommend that a licensed plumber evaluate and repair or replace as needed.

Visible standing water. Water appears to be leaking thru electrical housing for motor.

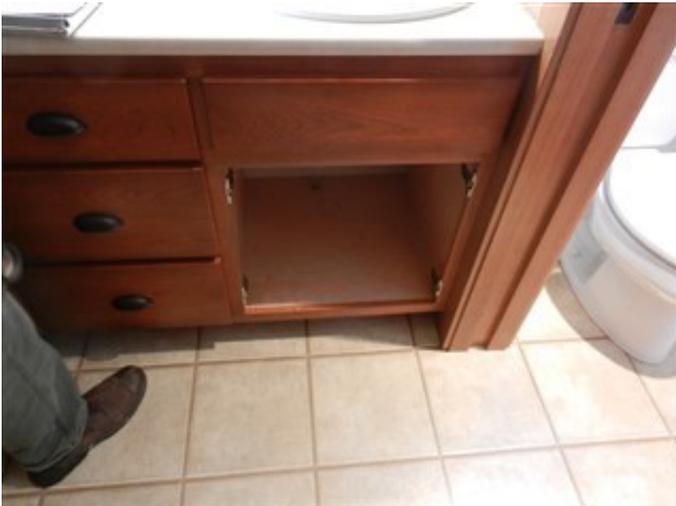
Photo 15-1

15) Cabinet in upstairs bathroom is missing a door. Request will need to be made to owner of availability. Install when found.

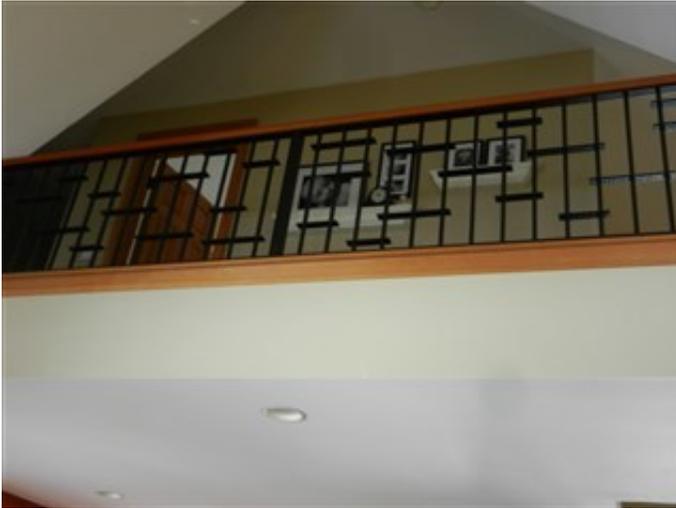
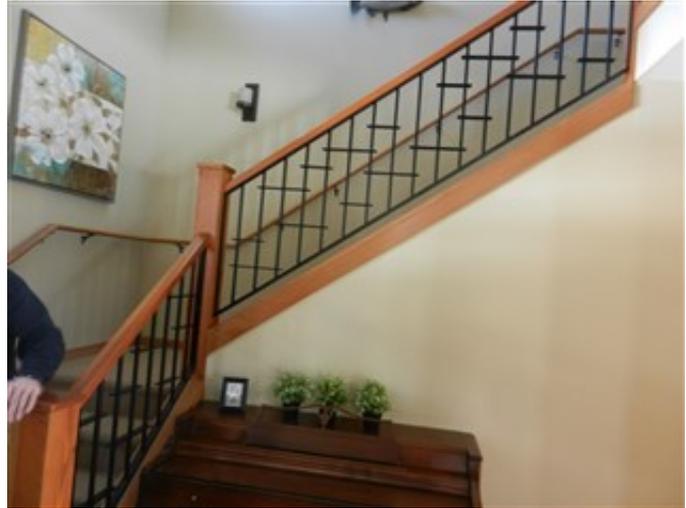
Guardrails at stairs and over living have horizontal bars for appearance. I just want to point out that these bars create a ladder effect, in that a younger child could use them to crawl up the guardrail. This could lead to a safety item for children.

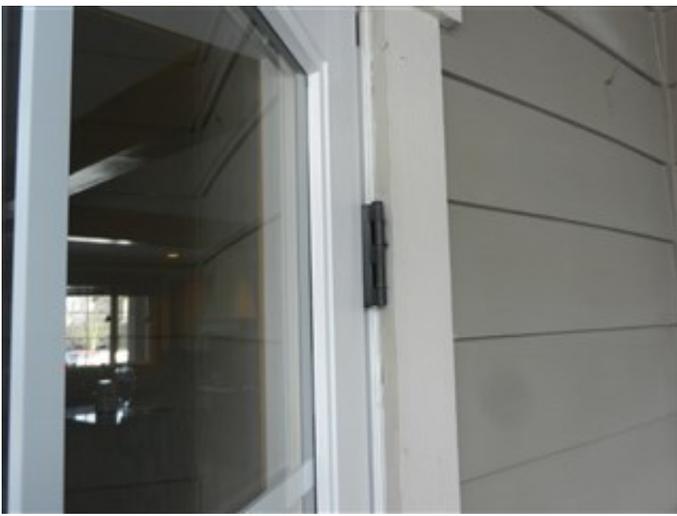
Photo 17-1

Double swing doors off the dining is a outswing feature. The hinges are visibule to the outside. The hinge pins are easily removed and would allow for entry to the home. This is a security issue. They could be changed to a non-removable hinge pin. Recommend that a qualified person repair or replace as necessary.

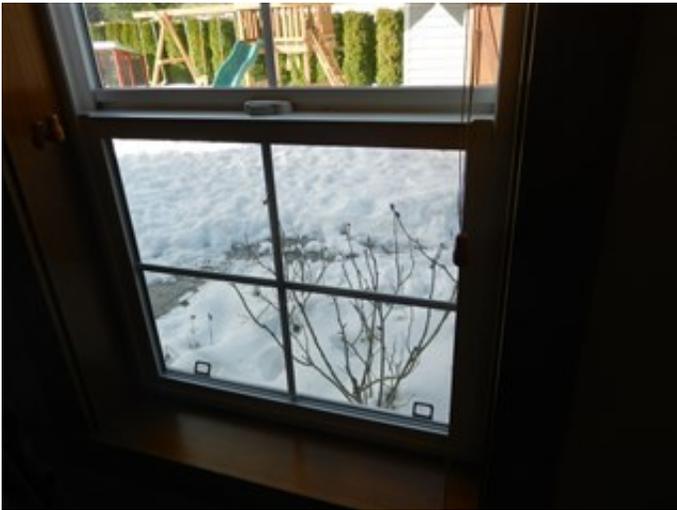
Photo 18-1

18) Dining, living and bedroom window are experiencing problems with the hardware needed to make opening and closing easy. This is a inconvenience and they can be replaced. Recommend that a qualified window supplier repair hardware.
